Exhibit 17

Building Moisture Survey

The property at 398 Augusta Dr, Telford, PA 18969 was the subject of a visual, moisture meter or an infrared (IR) survey on 2/27/2017. Areas agreed and designated by the client for this survey are listed in this document.

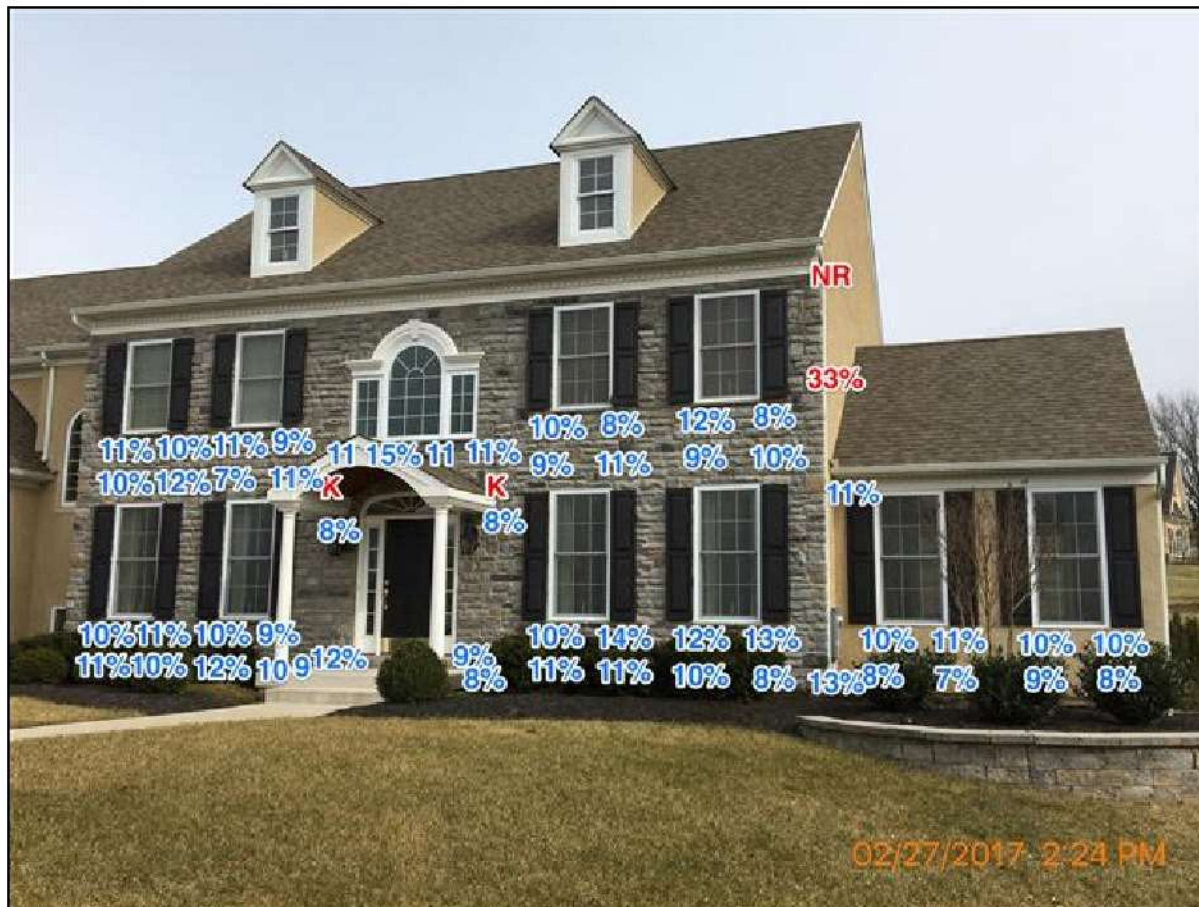
2.0 (Picture 1)

- **Observation:** Elevated moisture levels noted on this elevation.
- **Observation:** No resistance of the sheathing was noted on this elevation.
- **Observation:** Missing kickout flashing was noted on this elevation.
- **Observation:** The stucco and manufactured stone veneer is not adequately sealed around the windows, doors and other penetrations.
- **Observation:** The stucco and manufactured stone veneer is not adequately terminated or sealed at the fascia boards, rake boards, soffit returns and other terminations.
- **Recommendation:** We recommend destructive testing with further review and repair as needed.

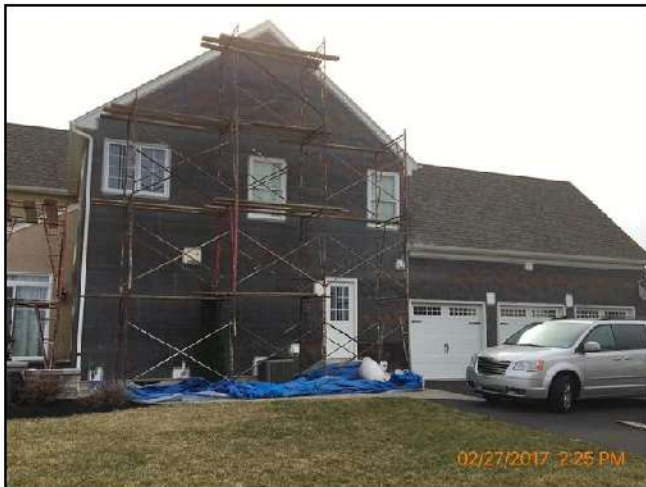
3.0 (Picture 1)

No moisture probe testing performed on this elevation. This elevation is under construction by the builder due to leaks at the windows, rake boards and possibly at the original expansion joint. All details have been covered with rain screen and some wire. No inspection of the new details was performed. It is recommended that the original cause be disclosed by the builder so that any proactive repairs can be made on the other walls if needed.

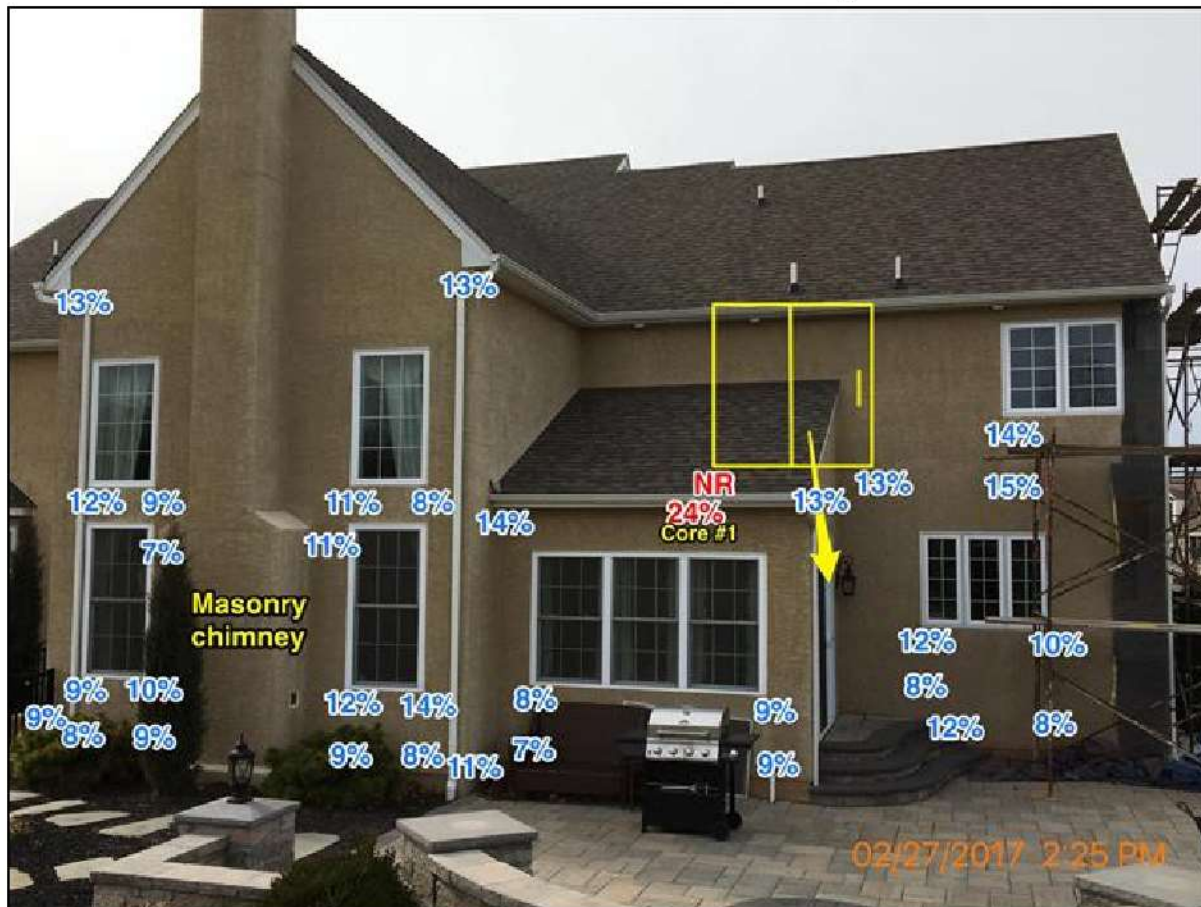
4.0 (Picture 1)

- **Observation:** Elevated moisture levels noted on this elevation.
- **Observation:** No resistance of the sheathing was noted on this elevation.
- **Observation:** Missing kickout flashing was noted on this elevation.
- **Observation:** The stucco is not adequately terminated or sealed at the fascia boards, rake boards, soffit returns and other terminations.
- **Recommendation:** We recommend destructive testing with further review and repair as needed.

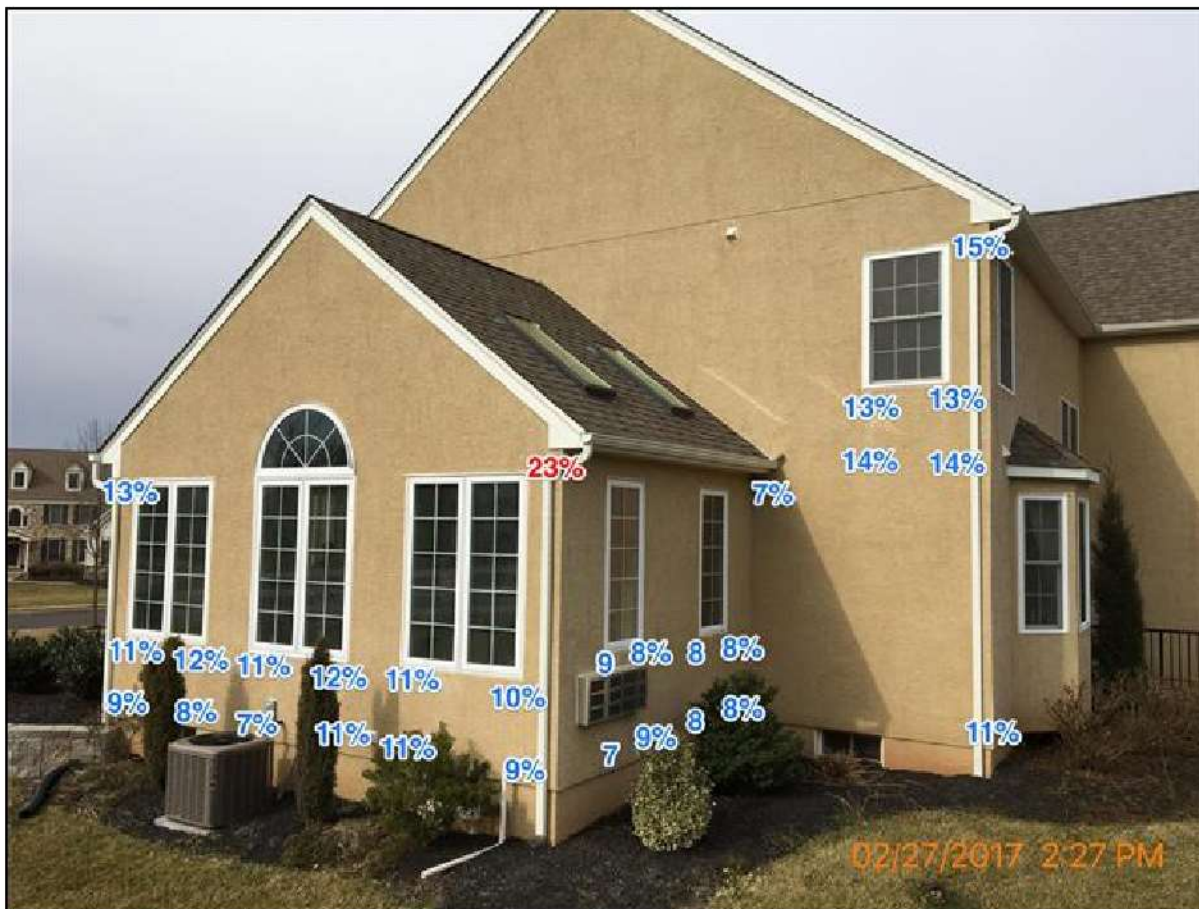
5.0 (Picture 1)

- **Observation:** Elevated moisture levels noted on this elevation.
- **Observation:** The stucco is not adequately terminated or sealed at the fascia boards, rake boards, soffit returns and other terminations.
- **Recommendation:** We recommend destructive testing with further review and repair as needed.

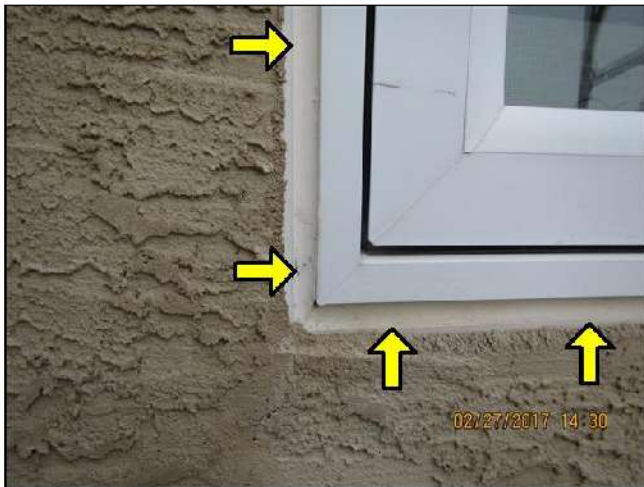
6.1 (Picture 1)

(1) Case bead and caulk joints were visibly noted to be installed around the windows.

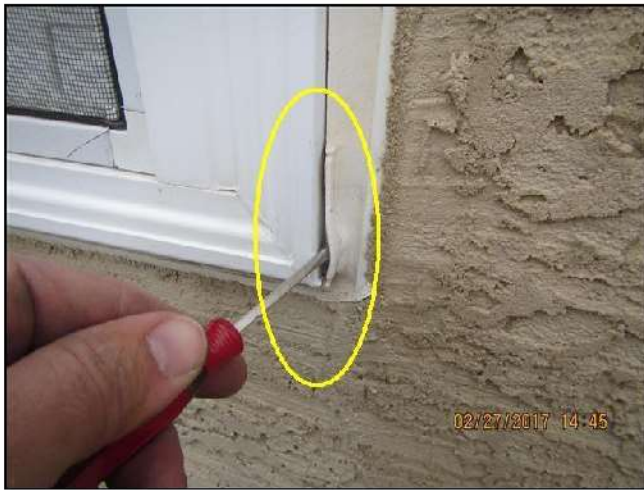
6.1 (Picture 2)

(2) The caulk joints were noted to be failing adhesively.

A foam material was noted between the windows and case bead which prevented proper adhesion of the caulk joint.

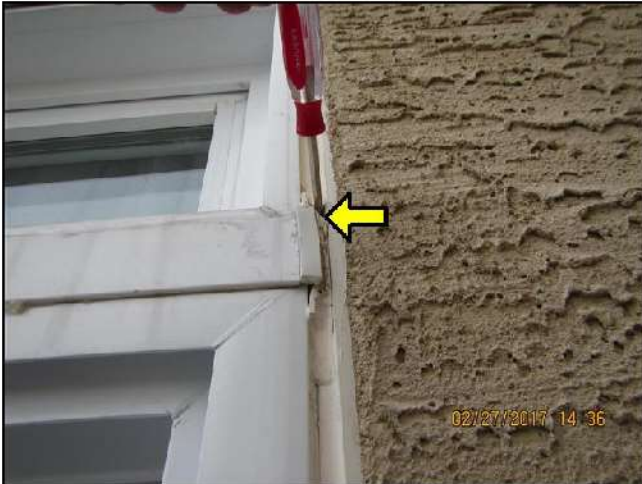
6.2 (Picture 1)

(1) The caulk joints are failing adhesively

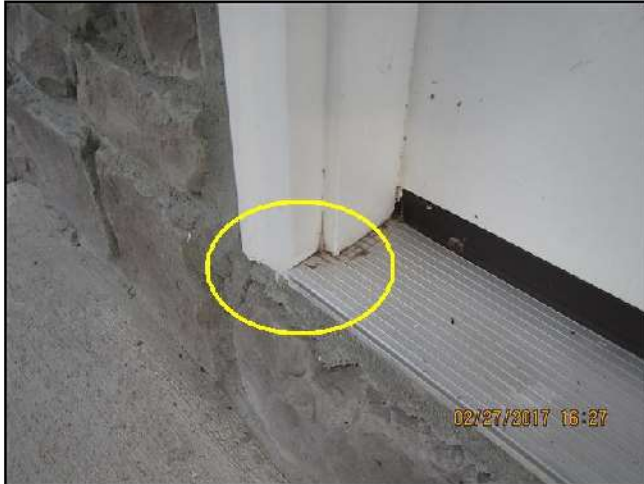
6.4 (Picture 1)

Openings and voids in the sill and jamb intersection can lead to bulk water intrusion. The best way to help manage moisture entry is with the use of proper sill pan flashing installed under the windows and doors with the use of caulking as well.

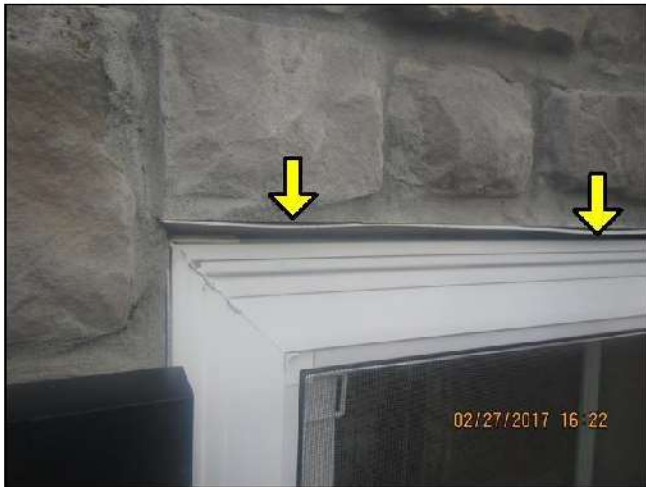
6.6 (Picture 3)

(2) Window head flashing was installed on the MSV, however it is flat and in some instances it has a negative pitch toward the home. This may force bulk water behind the cladding. Correcting the pitch is recommended or the installation of sealant end dams incorporated with proper sealant joints on the sides and bottom.

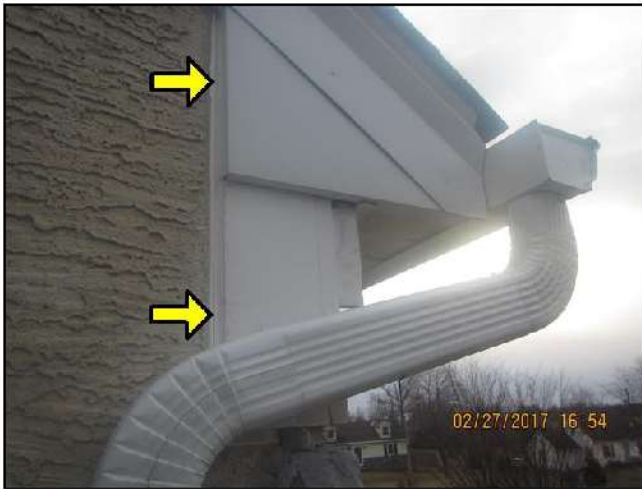
6.10 (Picture 7)

(2) A sealant joint was installed along one of the rake board/soffit returns at the front of the home, but it was failing adhesively and elevated moisture readings were noted.

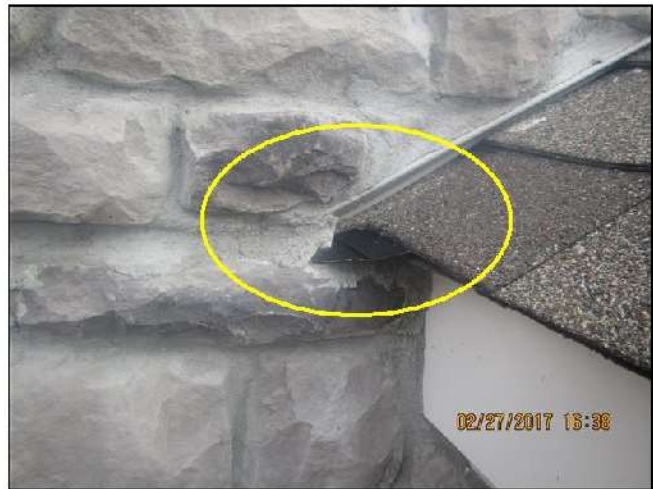
6.11 (Picture 6)

(2) Kickout flashing was not installed at the roof/wall intersections at the front of the home and the rear of the home.

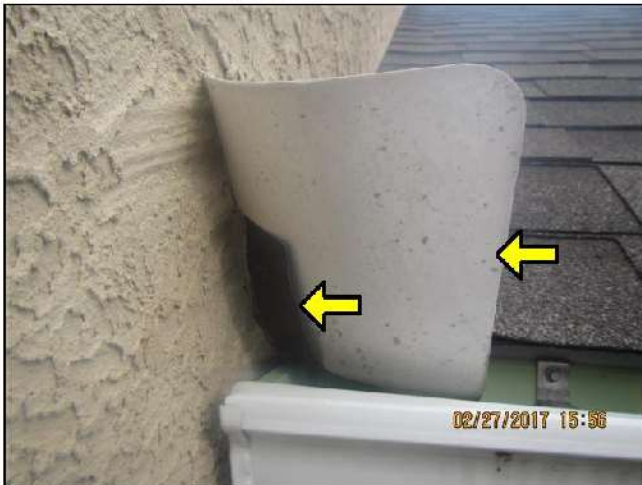
6.11 (Picture 7)

(3) A larger one piece kickout was installed over and original smaller two-piece kickout. This appears to have happened at the time of construction. It is not clear why the original inadequate kickout was not pulled when installing the new ones. That would have been a more adequate installation. A nail was noted through the kickout in a few locations. This may present a leak point. The back sides of the kickouts needs to be sealed.

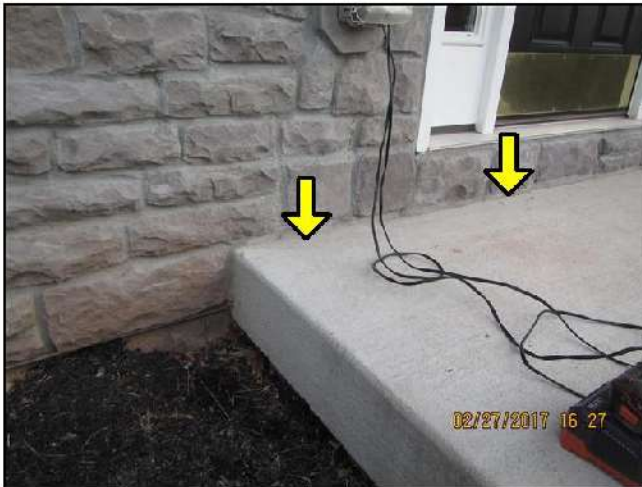
6.15 (Picture 1)

The stoop has been installed above the homes framing line without the visible installation of adequate drainage provisions. This may cause excessive moisture to be held against the home which can overwork the weather resistant barriers causing elevated moisture levels in the wood framing directly behind this location.

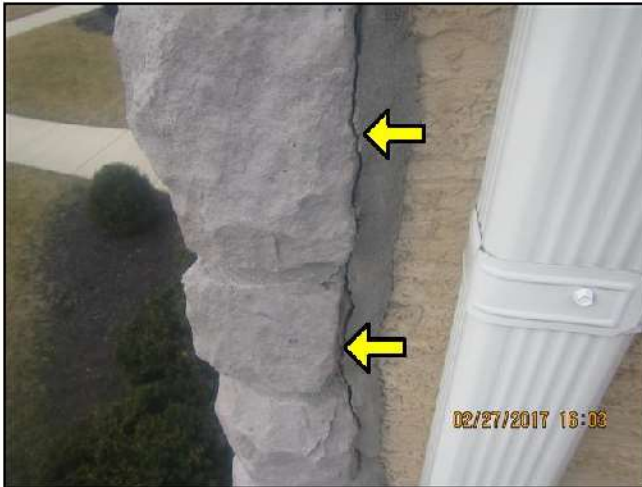
6.25 (Picture 1)

(1) Cracking and loose mortar was noted along the edge of the MSV.

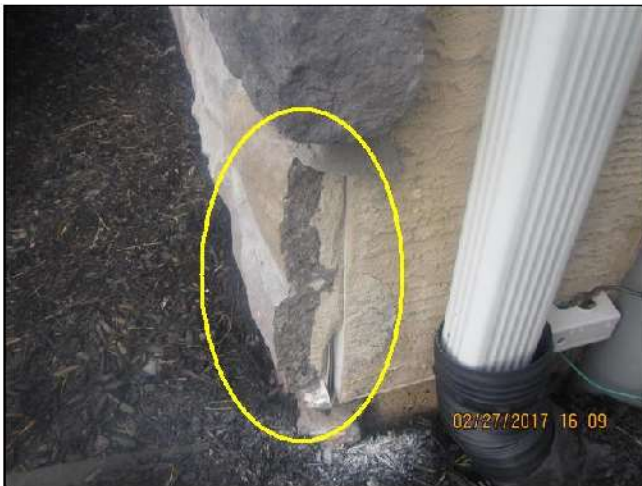
6.25 (Picture 2)

(2) Broken stones were noted at the base of the MSV wall.

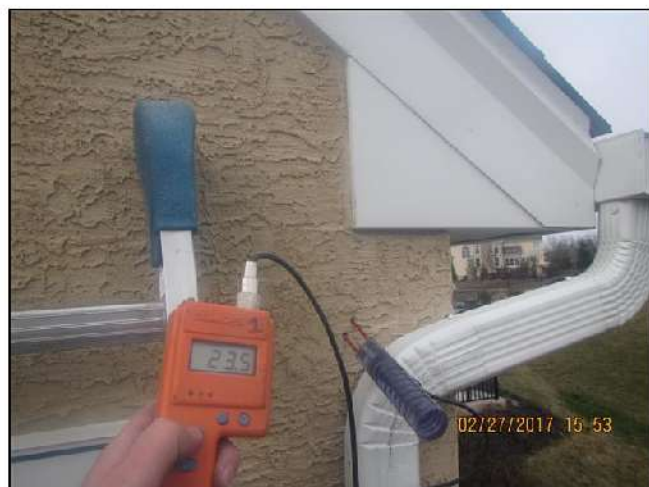
6.37 (Picture 1)

Example of elevated moisture levels noted utilizing a calibrated and insulated moisture meter.

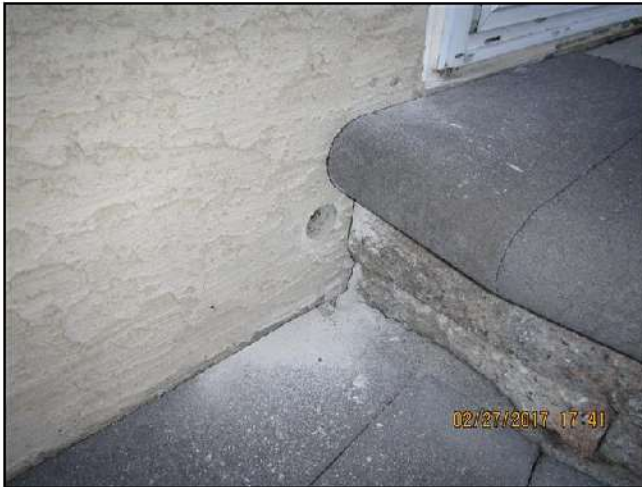
6.38 (Picture 1)

A core sample was taken at the rear of the home.

Wet sheathing was noted.
